1. REPORT NO. CA-DOT-TL-5167-4-76-18		2. GOVERNMENT ACCESSION NO.		3. RECIPIENT'S CATALOG NO.	
4. TITLE AND SUBTITLE REHABILITATION OF FAULTED PAVEMENTS BY GRINDING				5. REPORT DATE February 1976

REHABILITATION OF FAULTED PAVEMENTS
BY GRINDING

Study made by	Roadbed & Concrete Branch
Under the Supervision of	D. L. Spellman
Principal Investigator	J. H. Woodstrom
Co-Investigator	B. F. Neal
Report Prepared by	B. F. Neal

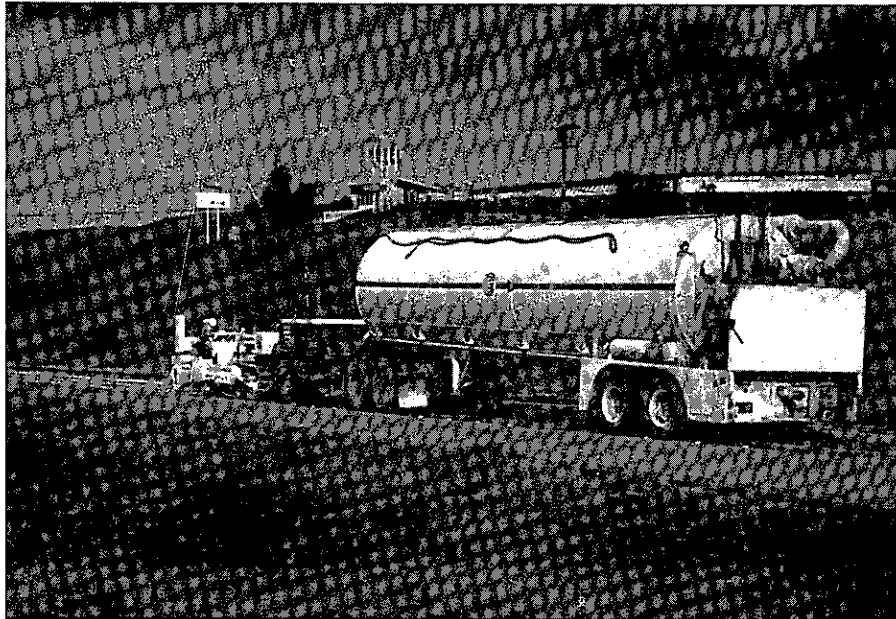
Fig. 1
Grinding equipment with tank for both
cooling water and waste water.

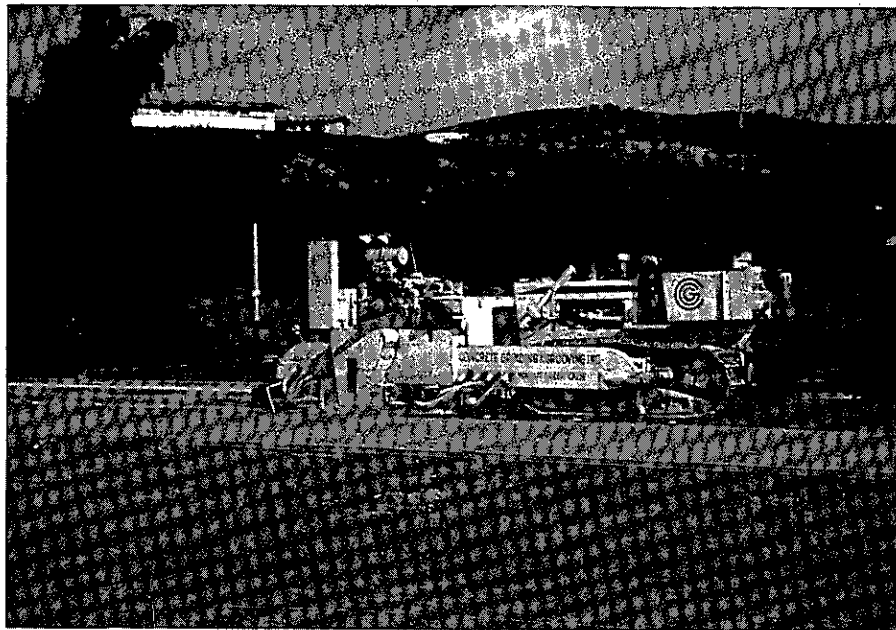
Fig. 2
Grinder in operation.

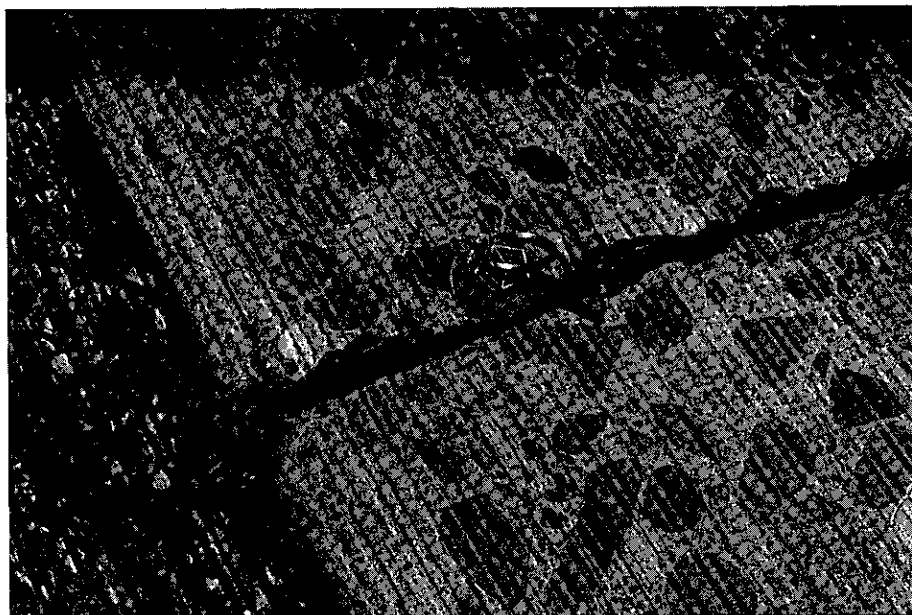
Fig. 5
Grinding across joint formed by steel insert.

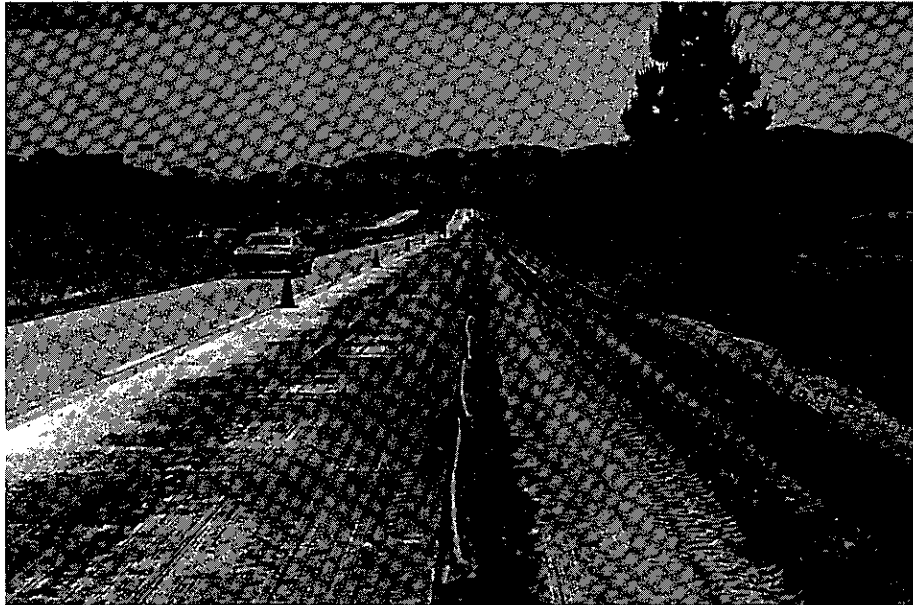
Fig. 9
General view of area with slotted drain pipe.

On another 1,000 ft. section a portion of shoulder adjacent to the pavement was removed and a 1-1/2 inch slotted drain was placed with out-drains every 200 feet. Hopefully, water that gets under the pavement will be removed before it can contribute
